Crash Testing and Analysis of Work Zone Sign Supports

Transportation Research Board

81st Annual Meeting
January 13-17, 2002
Washington, D.C.

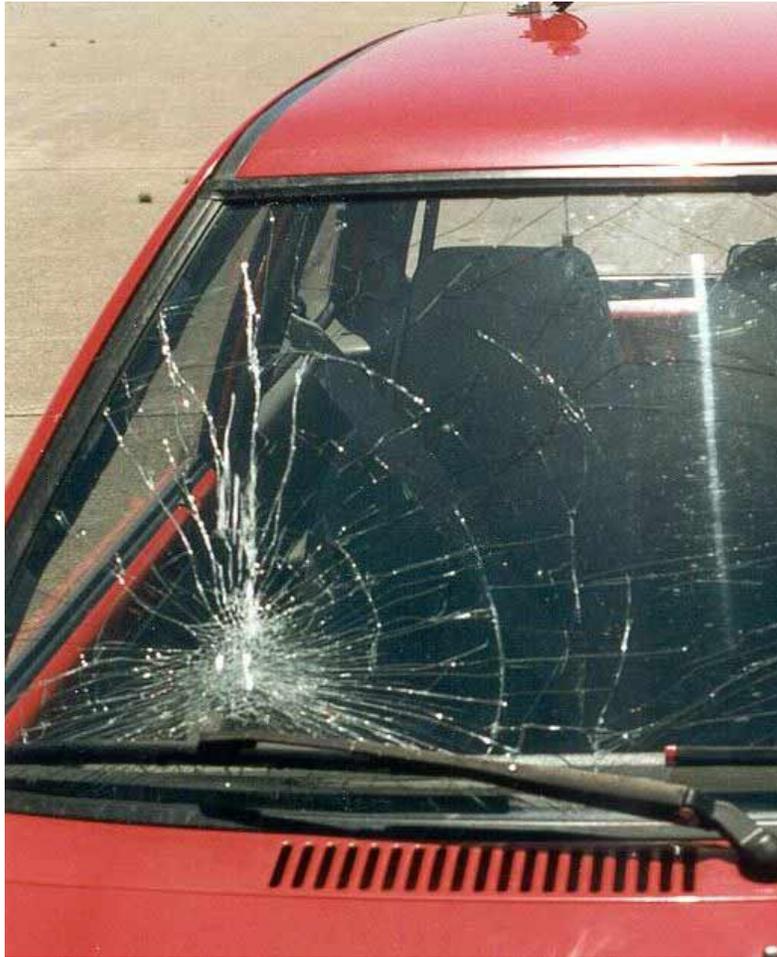
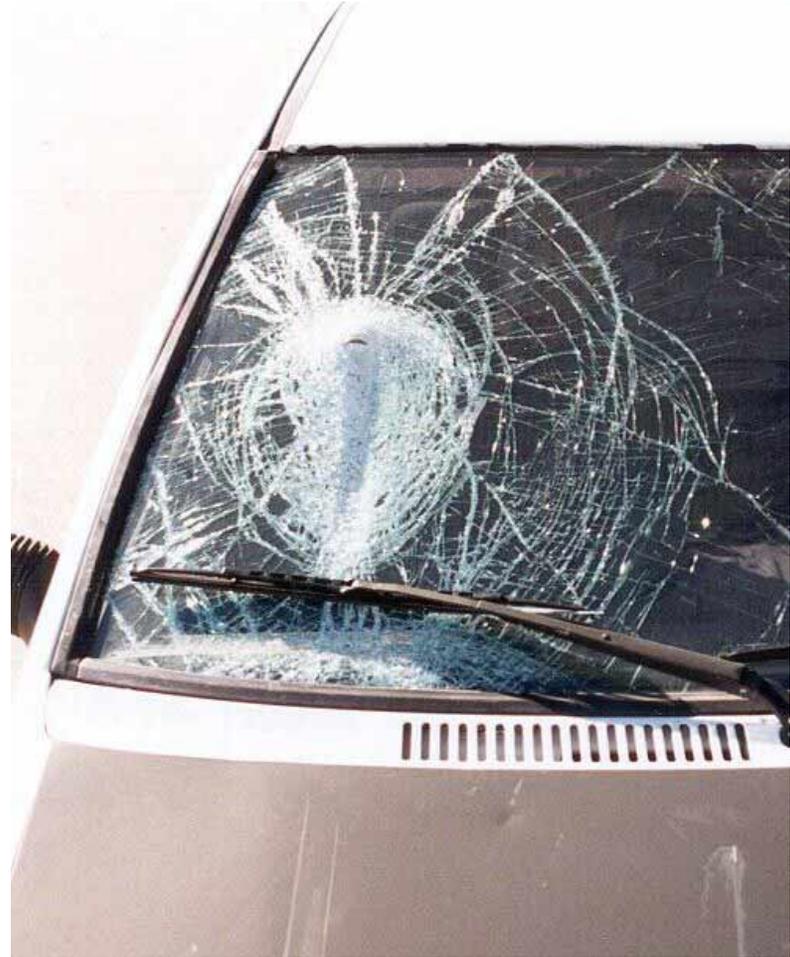
FIGURE 1 Windshield damage: pass and fail, respectively

Windshield damage is a major area of concern when evaluating the safety performance of a work zone traffic control device. The windshield should not be shattered nor damaged in a way that visibility is significantly obstructed. Minor chipping and cracking of the windshield is acceptable. Significant loss of visibility due to extensive “spider web” cracking at key regions of the windshield would deem the performance of the device unsatisfactory. Both layers of glass should not be fractured nor indented with the potential for the test article to penetrate the windshield. An example of satisfactory and unsatisfactory windshield cracking is shown in Figure 1.

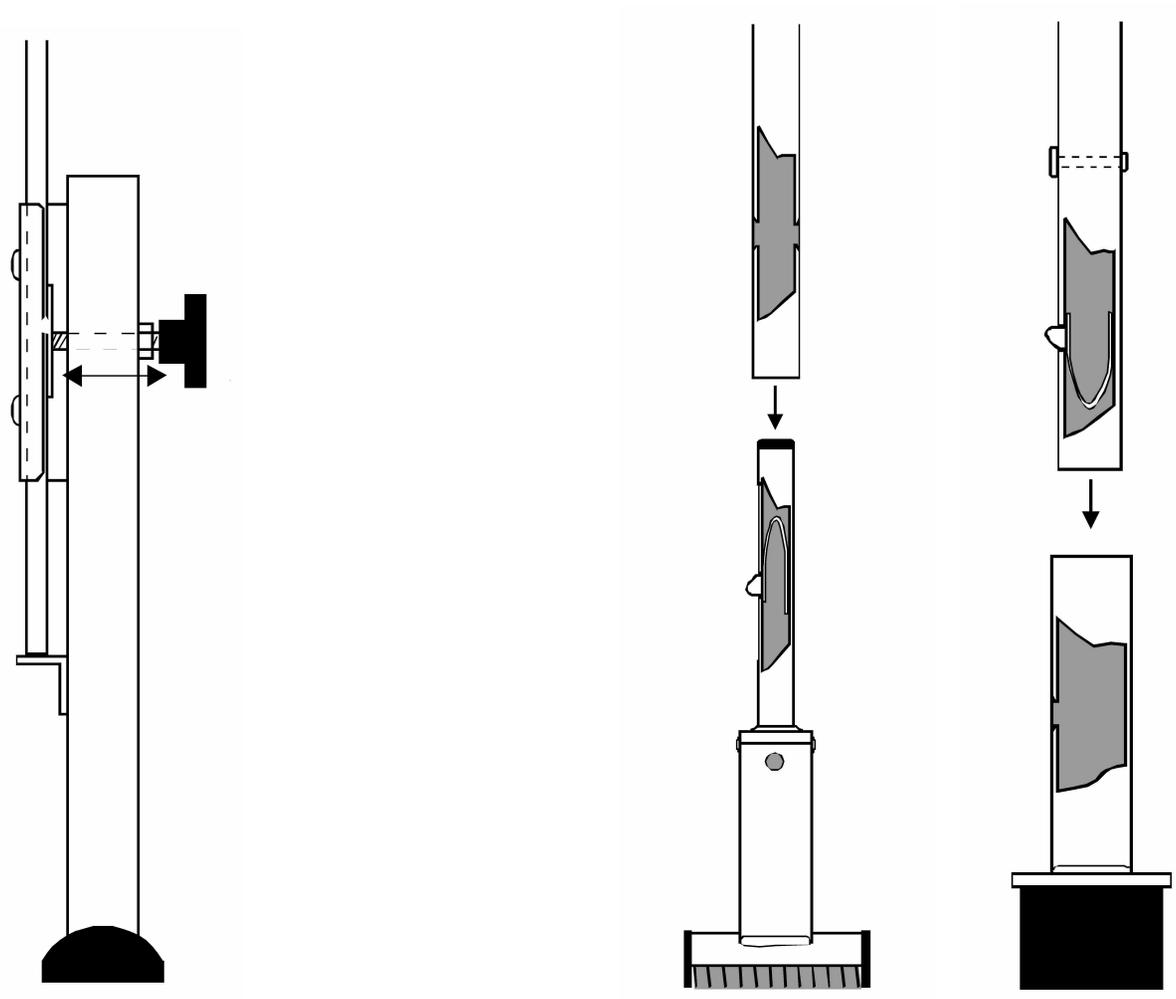
FIGURE 2 Sign lock mechanism: screwlock and stablock

The comparison made using generalized properties of the major sign components included only the sign support systems that contained a sign locking mechanism of either a screwlock or a stablock design as shown in Figure 2. For all the systems evaluated, the aluminum vertical tubing ranged in size from 30 to 45 mm square with wall thickness between 1.4 and 2.6 mm. The comparison was performed for both the head-on (0 degree) and end-on (90 degree) orientations.

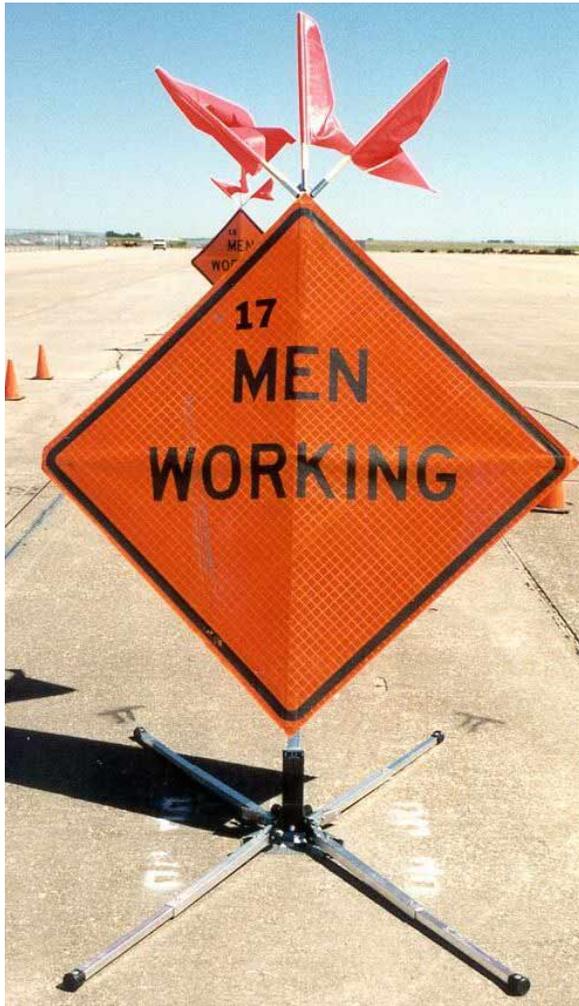
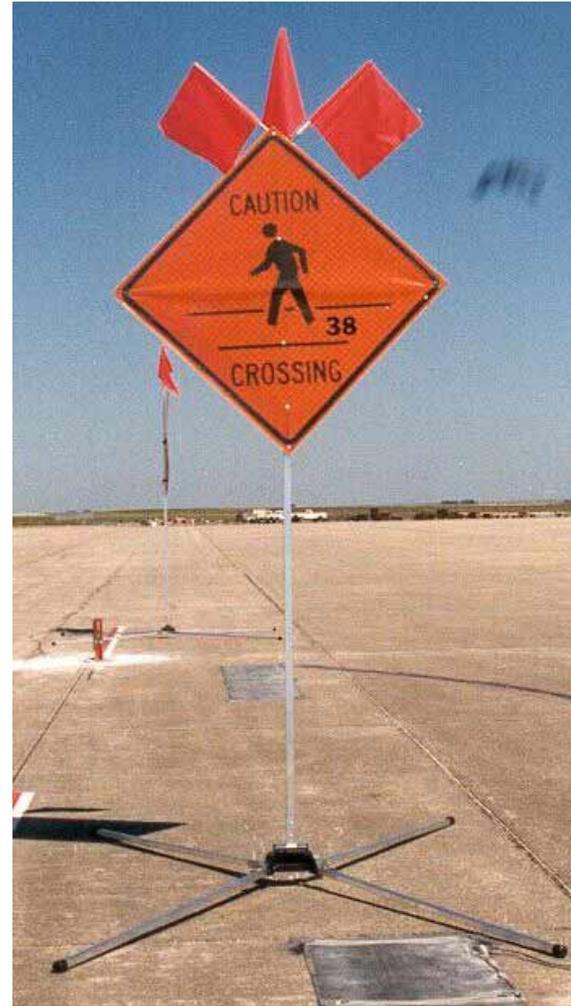
FIGURE 3 Heights to bottom of the sign panel: low and high, respectively

The parameters considered were the height to the bottom of the sign panel, base stiffness (spring), and section modulus at bumper height. The height to the bottom of the sign panel was placed in one of two categories: (1) low, which included heights up to 500 mm above the ground; and (2) high, which included heights greater than 500 mm above the ground. Examples of each height category are shown in Figure 3.

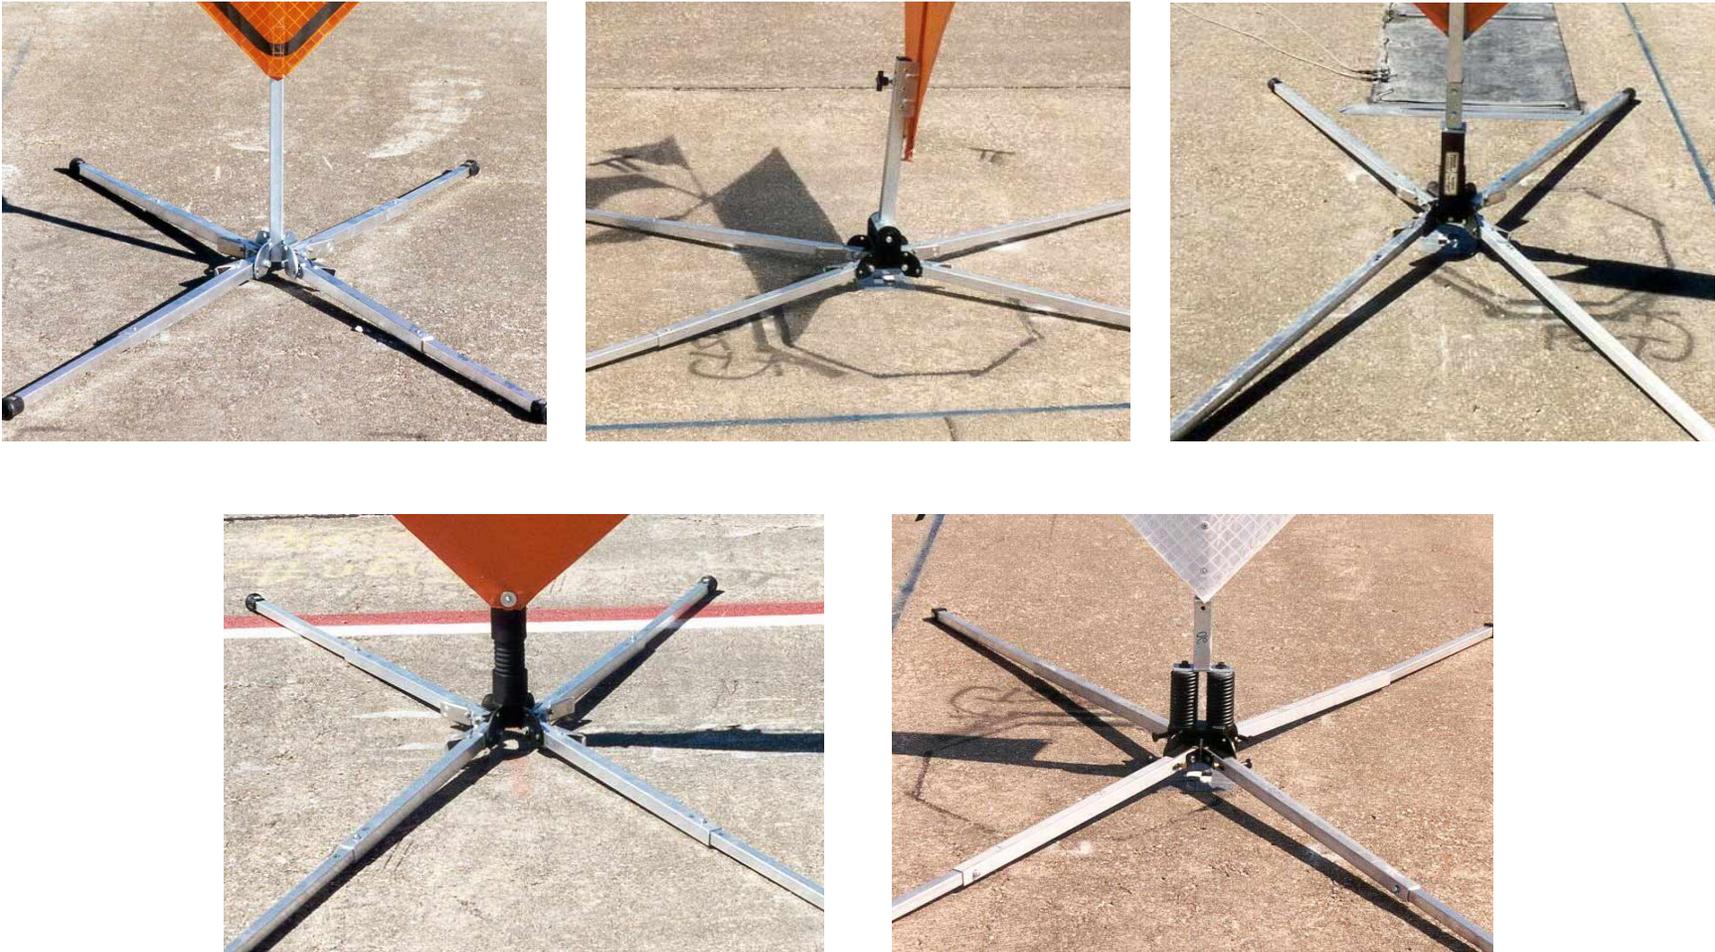
FIGURE 4 Base types: rigid, torsion spring, extension spring, single upright coil spring, and double upright coil spring

Base stiffness was also divided into two categories: (1) stiff; and (2) non-stiff. For the head-on orientation, stiff was used to describe the rigid base types and non-stiff was used to describe spring base types (i.e., torsional spring, extension spring, double upright coil spring, and single upright coil spring). For the end-on orientation, stiff was used to describe base types which were essentially rigid in the 90 degree orientation (i.e., rigid, torsional spring, extension spring, and double upright coil spring) and non-stiff was used for base types which still performed like a spring in the 90 degree orientation (i.e., single upright coil spring). Examples of the base types are shown in Figure 4.

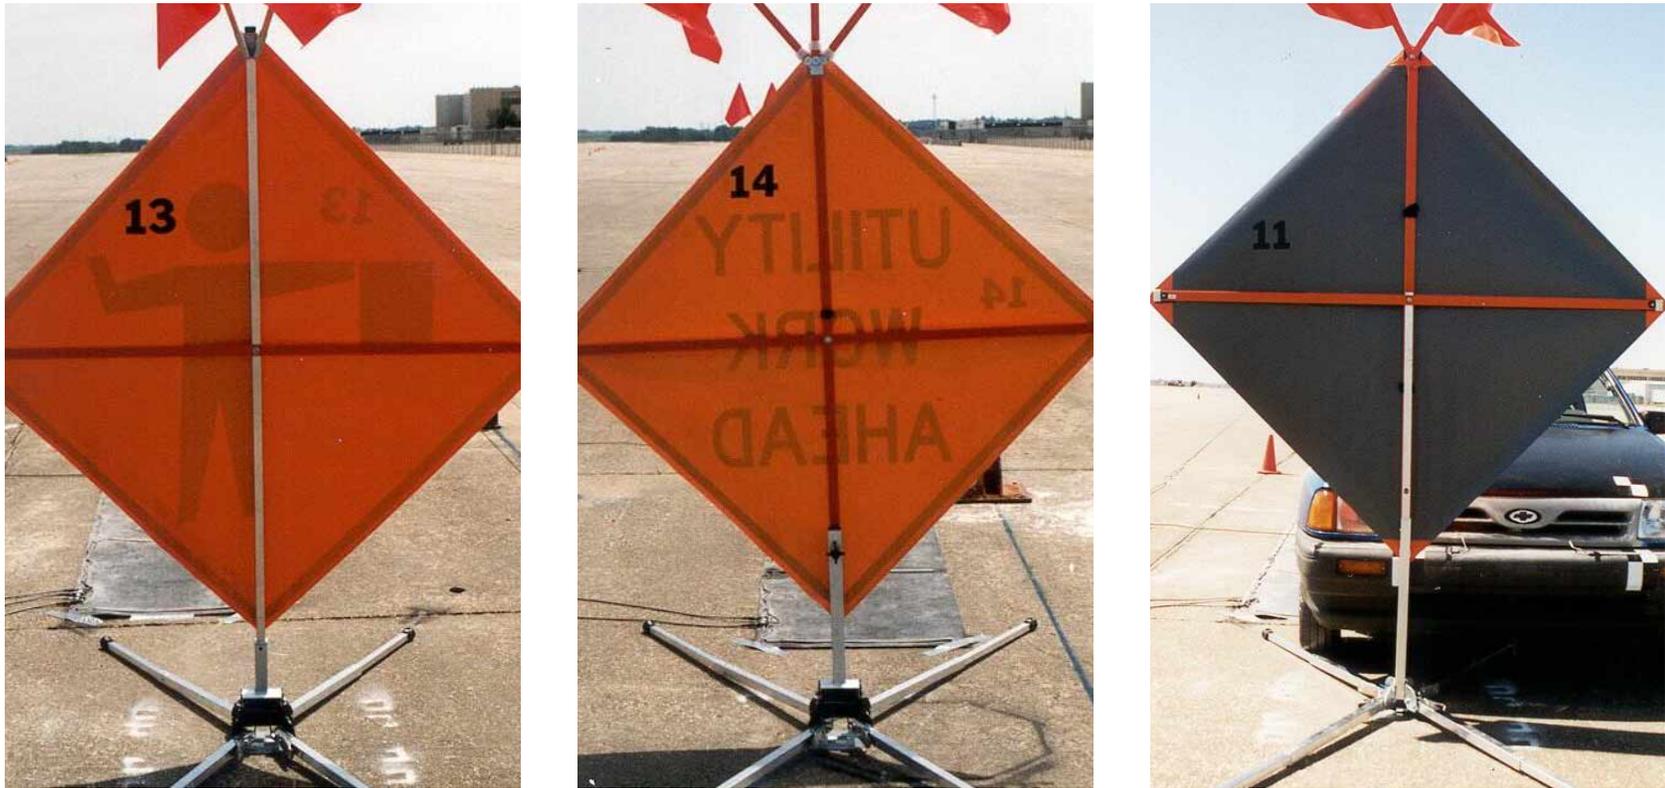
FIGURE 5 Bumper height stiffness: stiff, non-stiff, and combination

Bumper height stiffness was used to describe the section modulus of the mast and/or sign panel vertical crossbrace at the bumper height. The stiffness was divided into three categories: (1) stiff; (2) non-stiff; and (3) combination. Examples of each category are shown in Figure 5.

The stiff grouping included the systems that had an aluminum mast spanning the height of the sign panel and also the sign panels that had an aluminum vertical crossbrace member. The sizes of the non-stiff grouping included systems that did not have an aluminum vertical crossbrace member or mast. The “combination” grouping contained those systems with an aluminum vertical tubing connected to the base and the sign panel, but the sign panel contained a fiberglass vertical crossbrace member.

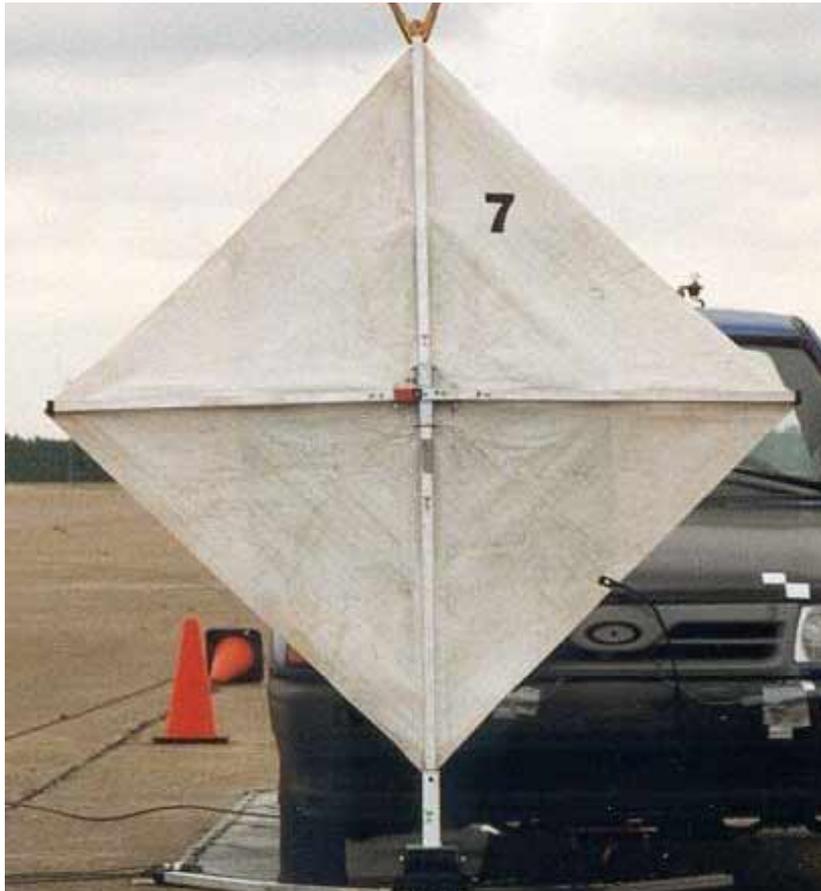
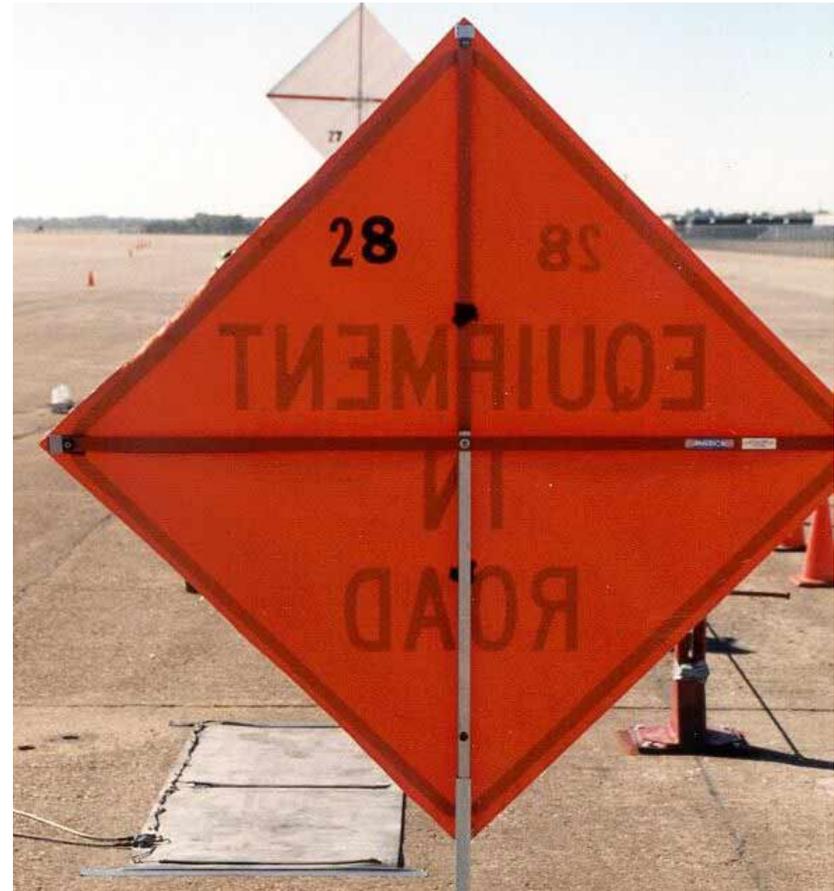
FIGURE 6 Material of horizontal crossbrace members: aluminum and fiberglass, respectively

As for systems with low heights, stiff bases, and stiff bumper height stiffness, the system's performances in the end-on orientation were varied. When comparing parameters to determine their varied performances, it was found that the horizontal crossbrace member material, as shown in Figure 6, and the flag staff material were different. One system contained an aluminum horizontal crossbrace member and wooden flag staffs and performed unsatisfactorily because the horizontal crossbrace member penetrated the windshield. Another system contained a fiberglass horizontal crossbrace member and wooden flag staffs and performed unsatisfactorily because the wooden flag system holder impacted and penetrated the windshield. The system that performed satisfactorily contained a fiberglass horizontal crossbrace member and fiberglass flag staffs. Therefore, it would appear that a system with a low height, a stiff base, and a stiff bumper height stiffness would probably perform satisfactorily in the end-on orientation if the sign panel contains a fiberglass horizontal crossbrace member and fiberglass flag staffs.
